DOT/FAA/AR-98/22

FAA T53-L-13L Turbine Fragment Containment Test

June 1998

Final Report

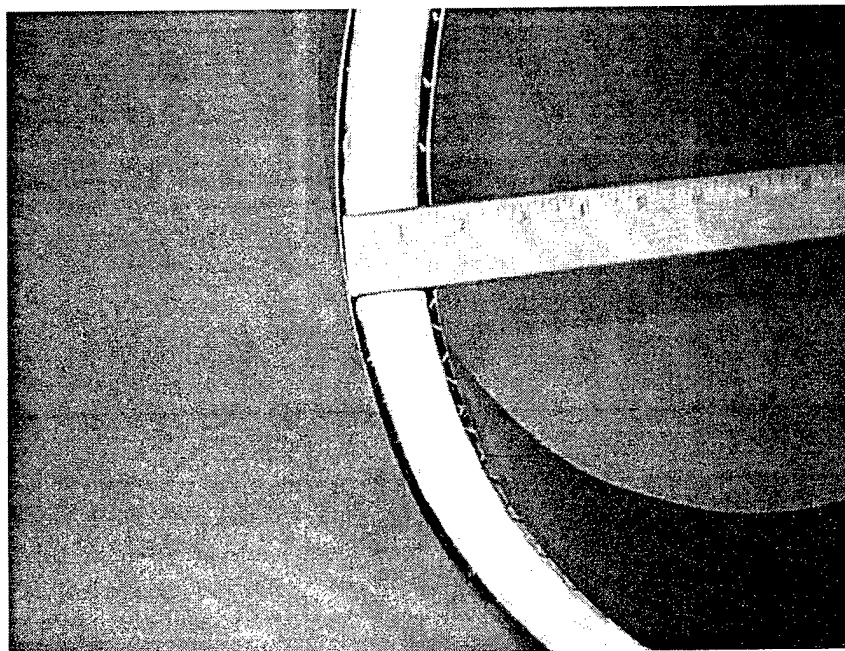
FIGURE 1. CONTAINMENT RING SECTION

The containment ring was developed and fabricated by Pepin Associates Inc. The ring was fabricated with a 0.014-inch titanium inner and outer sleeve. One-inch-thick Kevlar 29 ballistic fabric made up the primary structure of the containment ring. The ring was strengthened with titanium rods which were inserted through the fabric and laser welded to the inner and outer sleeves (figure 1). The ring weighed approximately 25 lbs. The containment ring was installed on the test engine and loosely connected to the engine case. The ring was centered on the second stage power turbine.

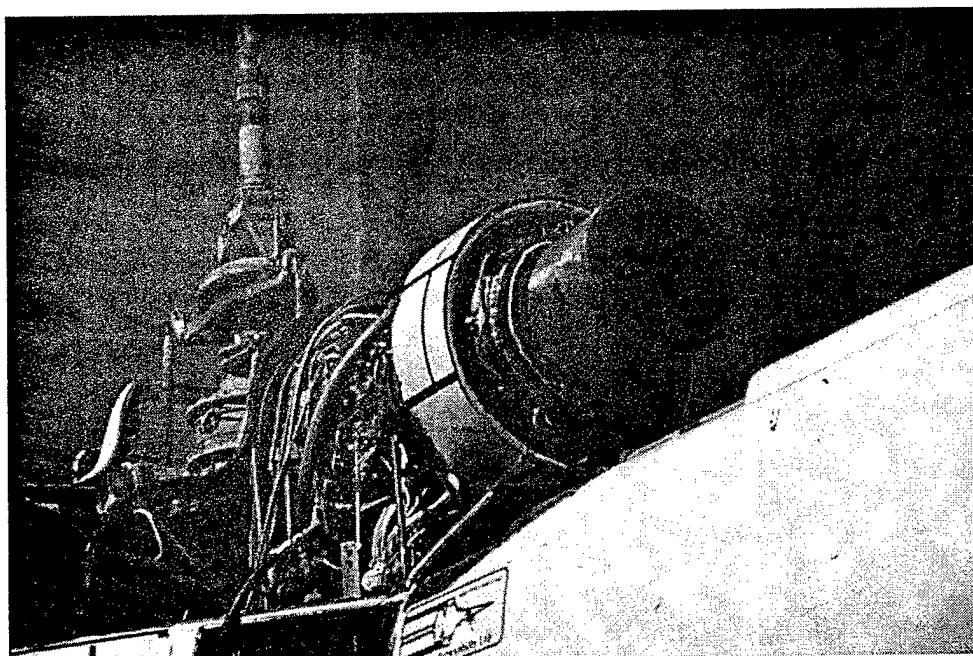
FIGURE 2. PRETEST INSTALLATION

The T53 engine was then installed in an UH-1 Huey helicopter (figure 2). The helicopter was mounted on two 2-foot-thick cement blocks and cabled down to three 1-foot-thick cement blocks (figure 3). The rotor head was removed to simplify the test setup and preparation. The engine was remotely started and operated. An emergency shutoff valve was located near the engine interface.

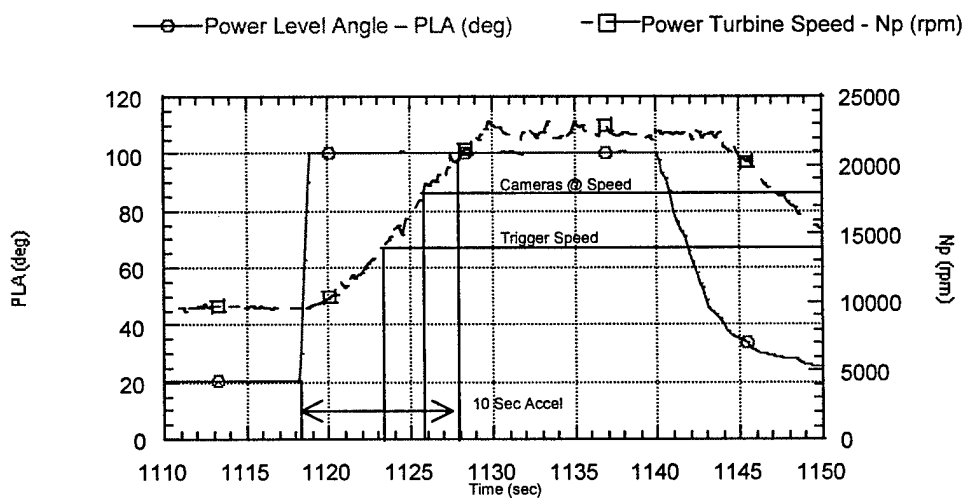
FIGURE 4. ENGINE ACCELERATION CALIBRATION

Even though the disk was notched, there was no way of determining exactly when or at what speed the disk would fail. To capture the event on high-speed film, a speed trigger circuit was used. There were approximately 8 seconds of film at a camera speed of 4000 pictures per second, 2.5 seconds of which were used as the cameras came up to speed. Prior to installing the test engine, a second engine was tested to determine the power turbine acceleration time from idle to maximum (figure 4). Multiple runs were conducted, and it was determined that the acceleration from idle to maximum was approximately 10 seconds. Idle speed was approximately 10,400 rpm and maximum was 22,500 rpm. Based on the engine acceleration times and the target rupture speed (20,400 rpm) and considering the camera time required to come to speed, a trigger speed of 14,000 rpm was chosen.

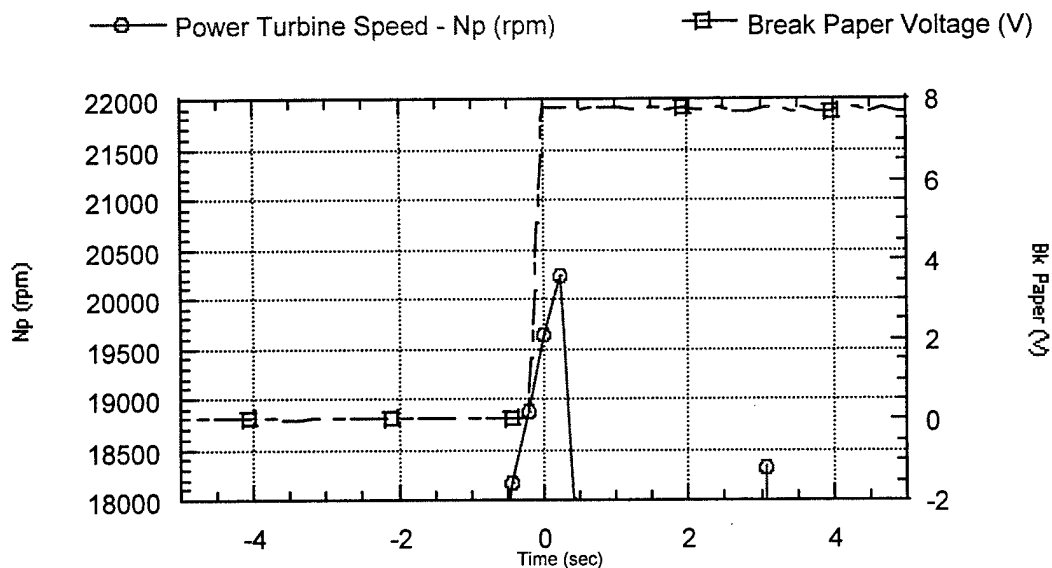
FIGURE 5. POWER TURBINE SPEED AND BREAK PAPER VOLTAGE VERSUS TIME TEST DATA

The test was completed as planned. The cameras were triggered as Np passed through 14,000 rpm. The disk released at 19,629 rpm. Test data are provided in figures 5 through 7. The disk ruptured into three nearly equal sections that were contained by the containment ring. The outer titanium shell split due to the tensile load resulting from the disk fragments pulling the Kevlar into a triangular shape. All three disk fragments penetrated the engine combustor case. The fuel lines located between the containment ring and combustor case were penetrated, resulting in a small fire. Secondary blade fragments exited the engine exhaust nozzle and a few fragments
